Limited Visual Dam Safety Inspection Summary Report

MA-134

Koapala Basin

Limited Visual Dam Safety Inspection Conducted on: 04 April 2006

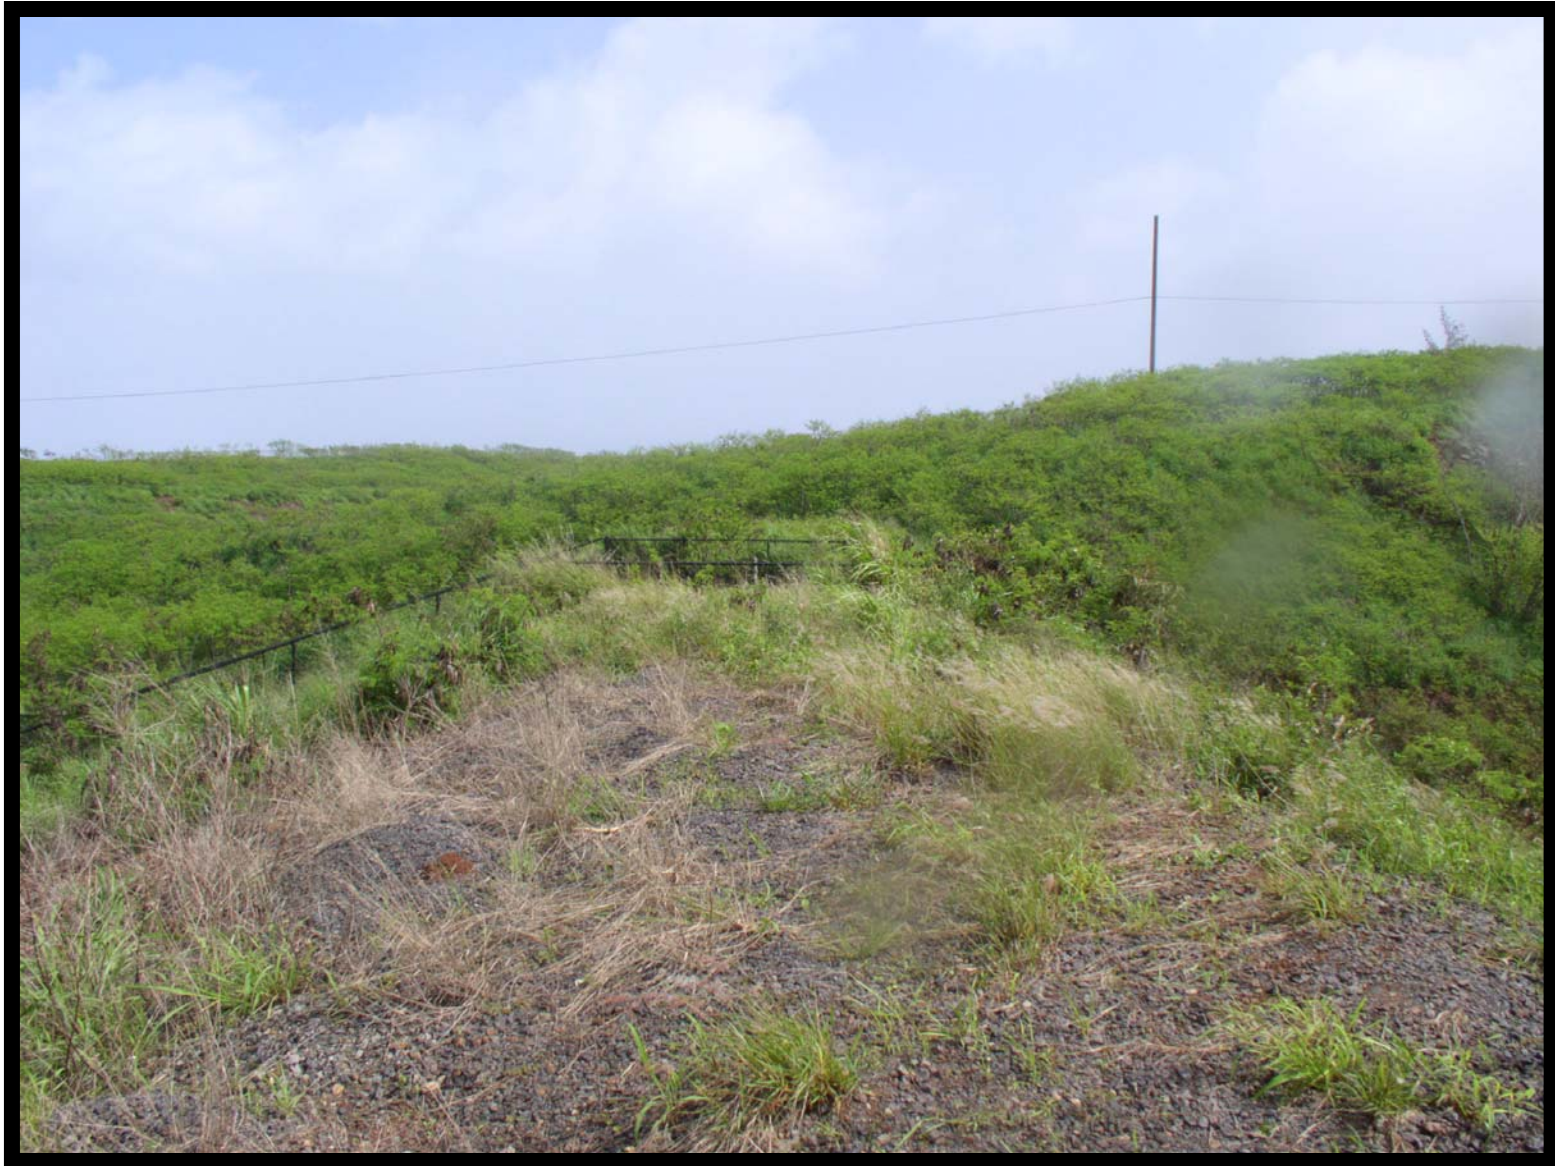
The dam crest was approximately 12 feet wide.
Cracks were not visible, however the crest was not entirely visible.
Sinkholes were not visible, however the crest was not entirely visible.

134 Crest - Note the part of the crest on the far side of the spillway is inaccessible.

- a. The dam crest appeared to be in satisfactory condition, no corrective actions are required at this time.

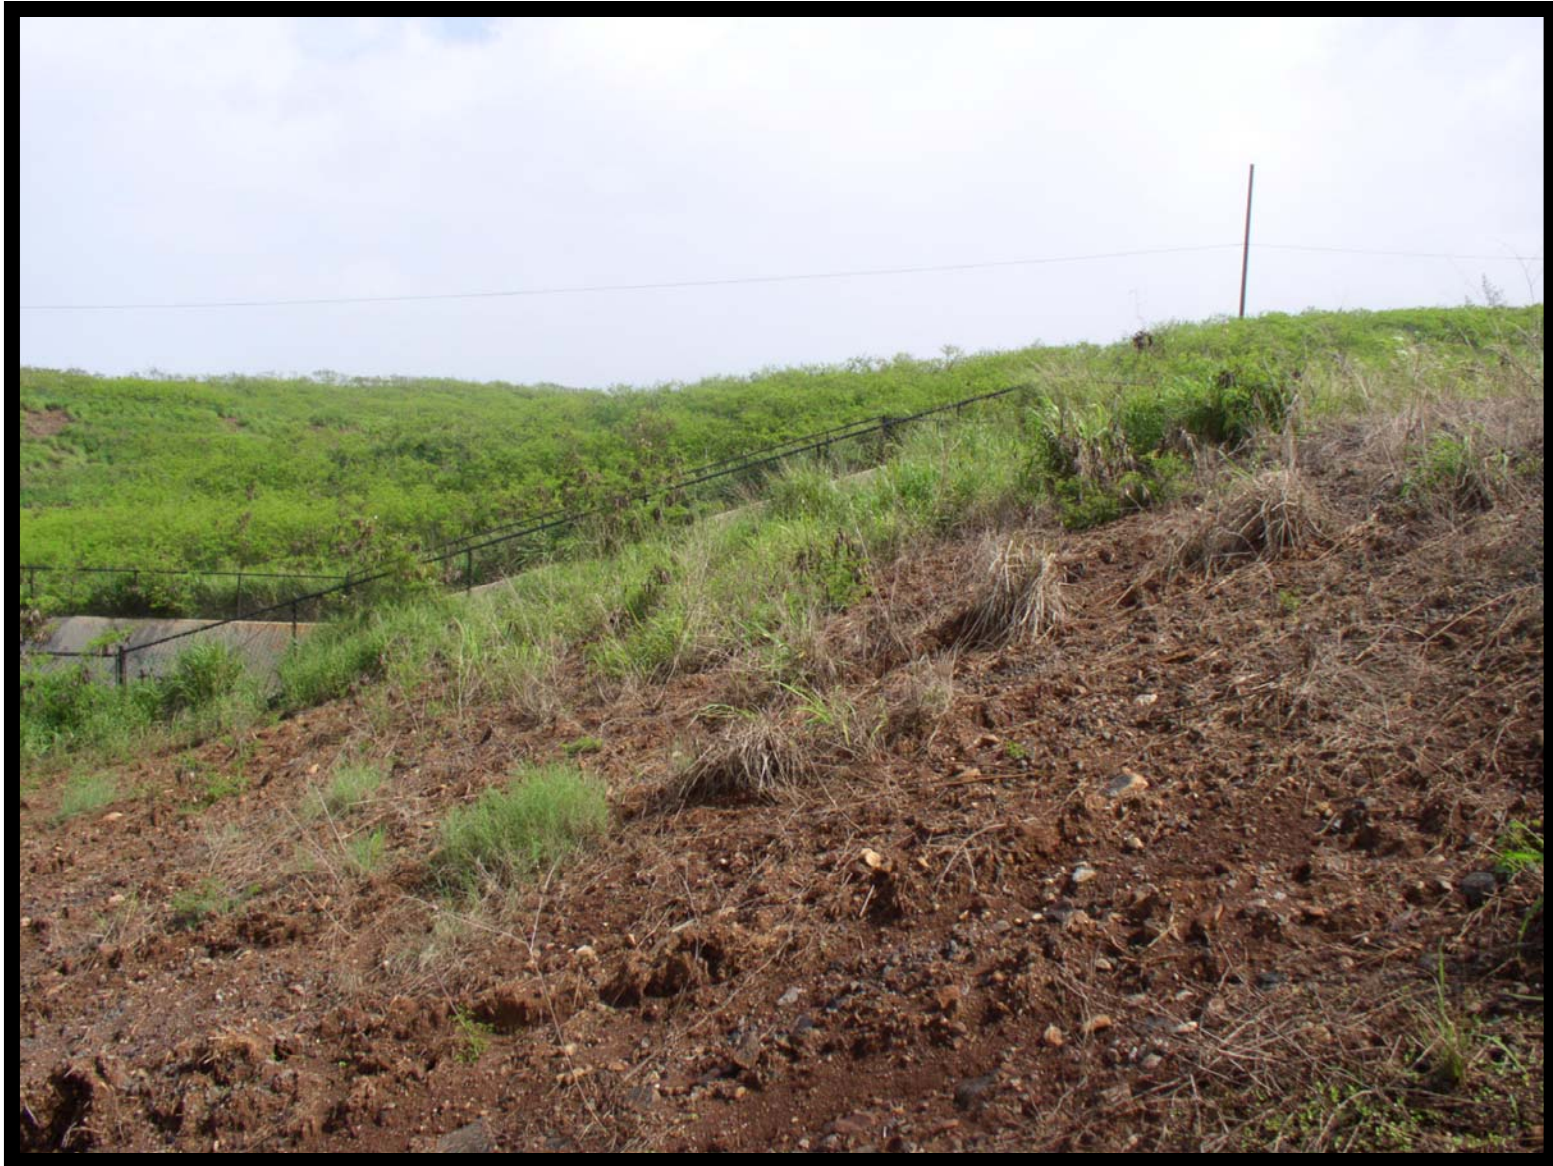
The slope was approximately 1 on 3 slope.

Vegetation was observed on the downstream slope. The majority of the vegetation was low ground cover.

134 Downslope - Note the part of the downstream slope on the far side of the spillway is inaccessible.

- a. The downstream slope appeared to be in satisfactory condition, no corrective actions are required at this time.

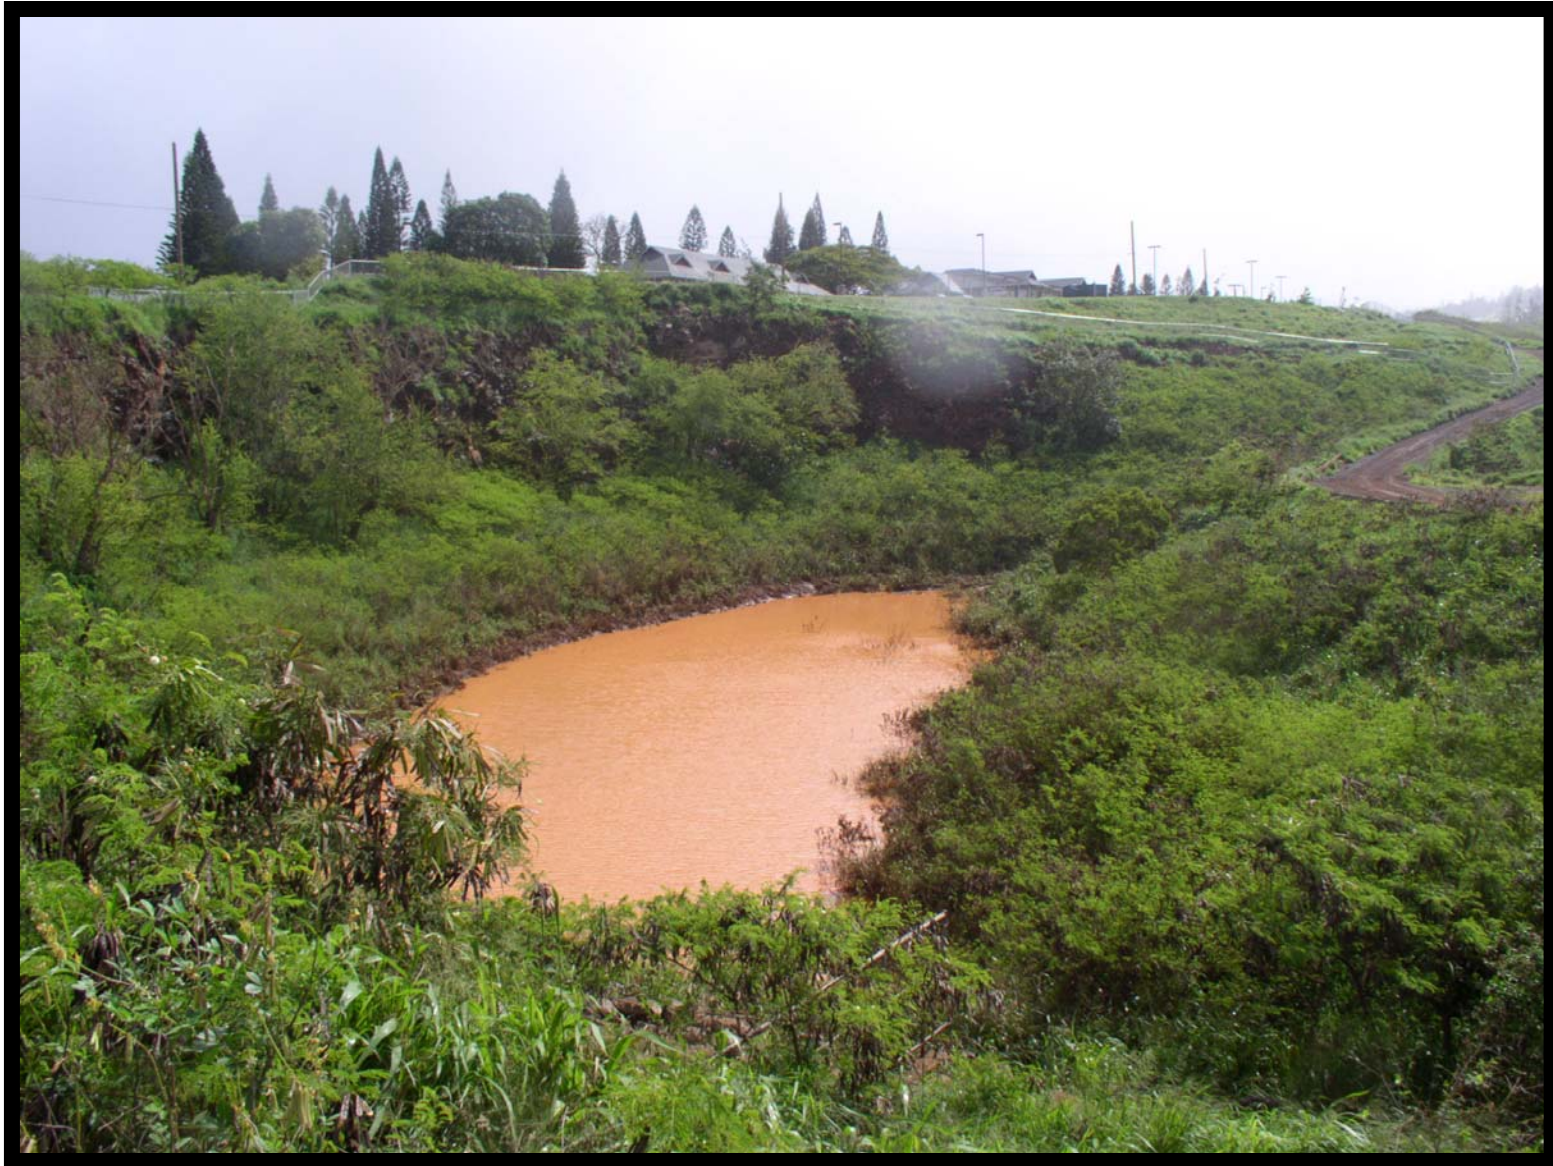
The reservoir level during the inspection was 4 feet. A staff gage was not observed. According to staff personnel, the reservoir is normally operated between the range of 0' to 6'.

- a. The reservoir appeared to be in fair to poor condition and requires corrective action.
- b. A staff gage was not observed at the reservoir. Provide some method of quantifying the water level within the reservoir.

134 Reservoir - looking upstream from the crest.

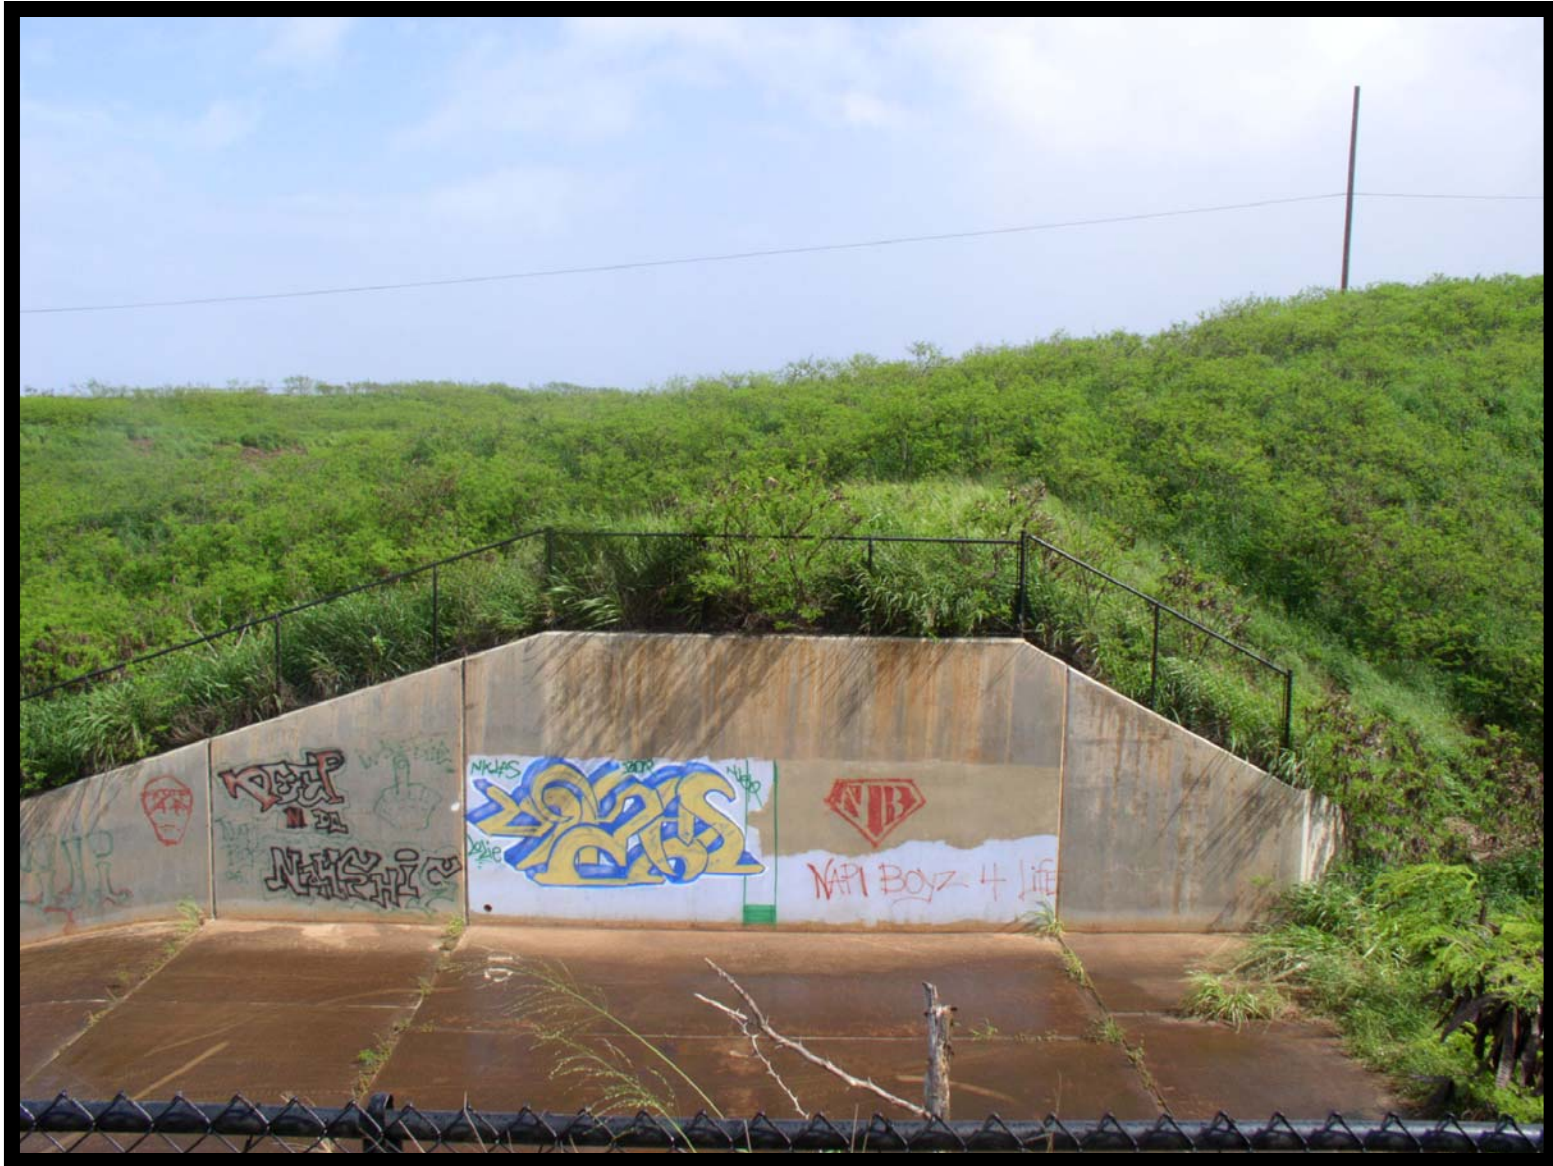
This spillway consisted of a 50-foot wide channel.
The spillway approach was clear.
There was no erosion observed near the spillway.

- a. The Spillway appeared to be in fair to poor condition and requires corrective action.
- b. Unclear if spillway is adequately sized. Spillway should pass the probable maximum flood. Verify spillway capacity and take corrective action as required.

134 Spillway - looking from the crest. Note the embankment on the far side of the spillway is inaccessible.

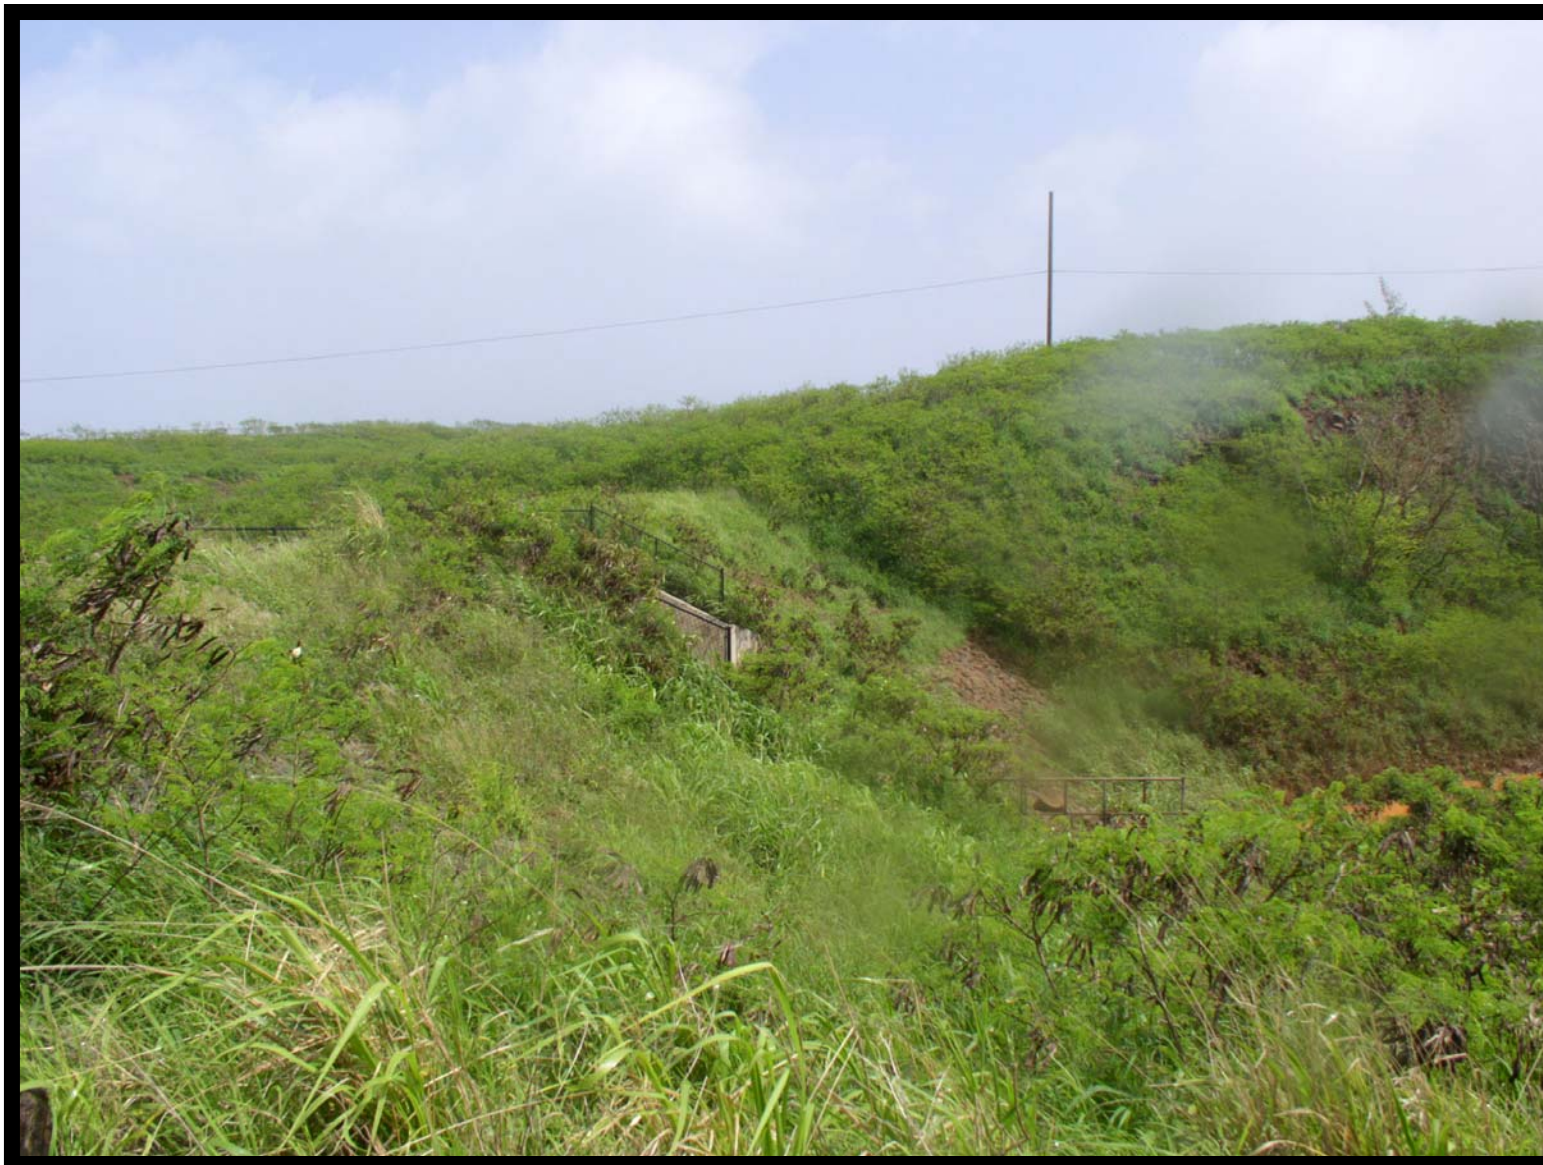
The upstream slope was approximately 1 on 3. Erosions were not visible; the slope was not entirely visible. Cracks were not visible; the slope was not entirely visible. Sinkholes were not visible; the slope was not entirely visible. The upstream slope was not entirely visible due to heavy woody and grass vegetation.

- a. The upstream slope appeared to be in fair to poor condition and requires corrective action.
- b. Slope protection needs maintenance and repair. Description: Mowing needed (too wet).

- c. The upstream slope was not visible due to high grass and bush vegetation. Clear high vegetation and maintain low to enable easy visual inspection.

- d. Tree(s) were observed on the dam embankment. Trees have been identified as the probable cause of piping failures, and can possibly cause severe damage to the embankment if they are uprooted during a high winds. Corrective action is required to remove the tree hazards from the dam. Acceptable remedies include removal of the tree and its root structure down to a 2" diameter and reconstructing the damaged embankment section. All repair work shall be accomplished as per the requirements of licensed geotechnical or structural engineer. Routinely monitor the damaged area for signs of settlement and seepage.

134 Upslope
